**JN Bentley
Hutton Cranswick SPS**

Utility Mapping Survey

Site Report – Rev A

Project No. 1775

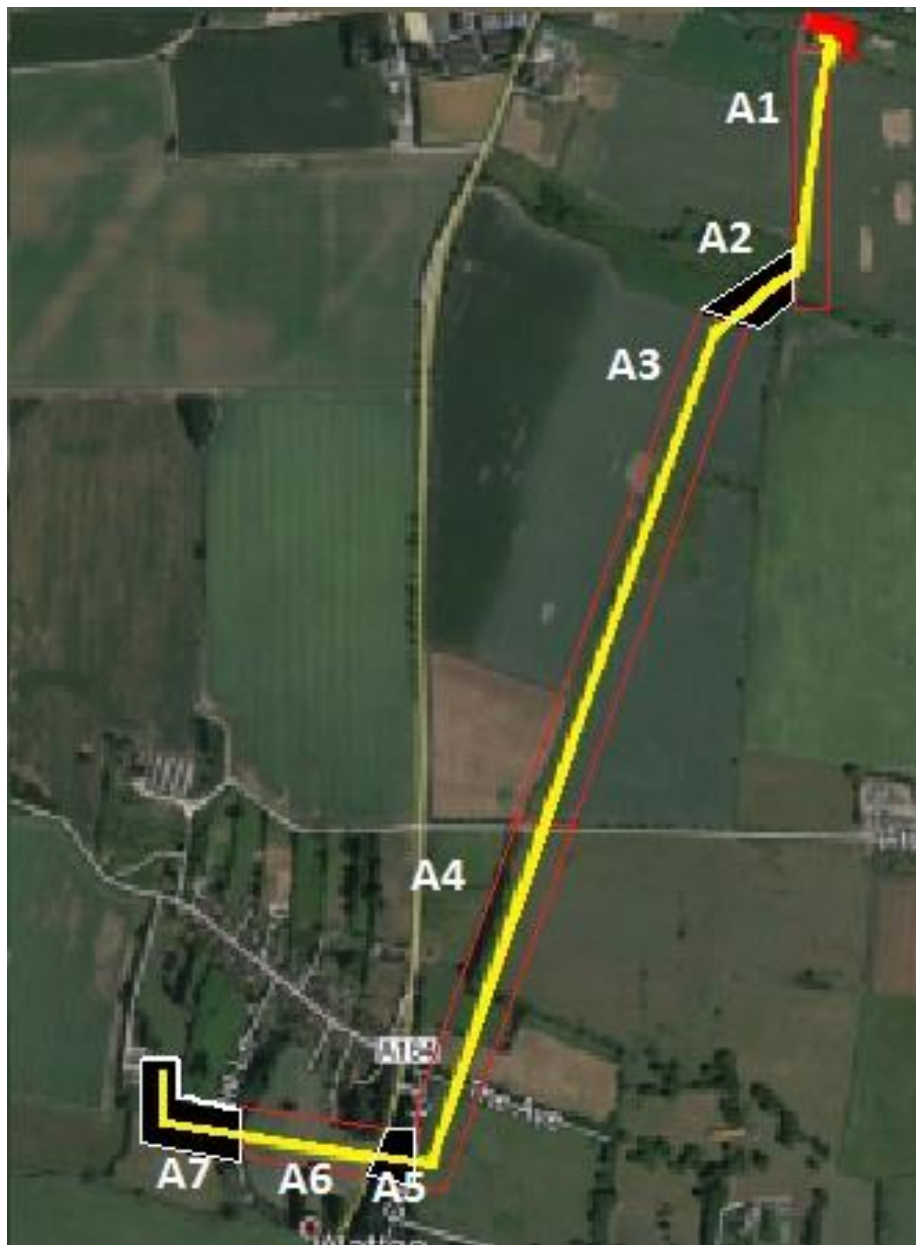
Photo 1

Description: Coverage plan;

A2- Ground too rough for the radar to work on, major movement in the radar will result in poor data and damage to equipment, ground to uneven/bumpy to survey.

A5- Area beside Beverley Road, no GPS signal due to overhanging trees and multiple parked cars in layby, and 50mph road and high traffic on Beverley road resulting in coverage of that area being abandoned.

A7- Same as A2, ground very uneven, damage to radar would occur and radar results would be too poor to interpolate, smaller area beside pumping station had locked gate, unable to contact land owner due to her living in another village and not on site.

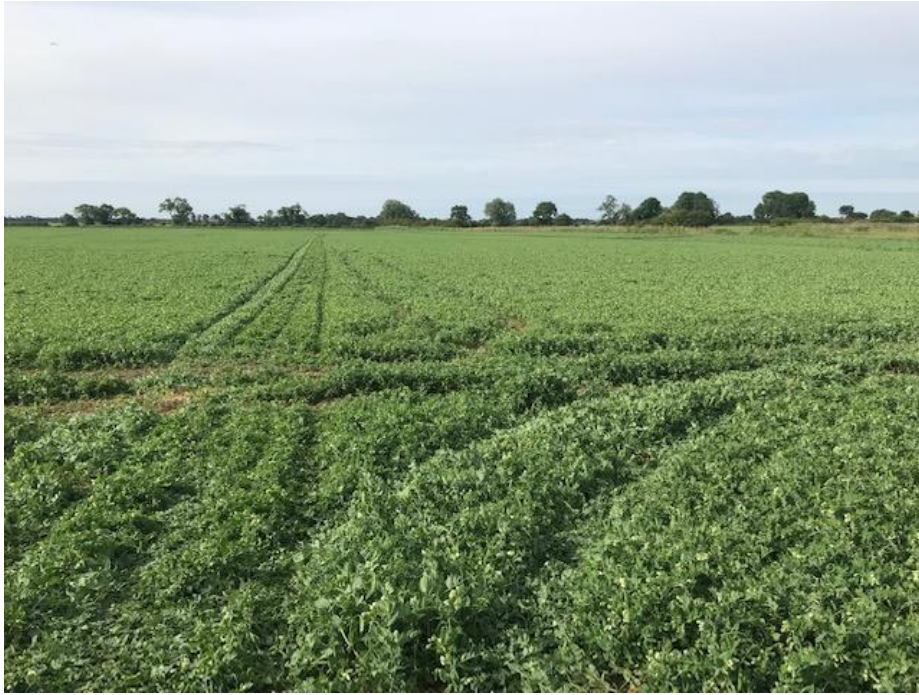
Photo 2

Description: Pea Field in A1. Photo taken before work commenced. Full coverage achieved with no issues.

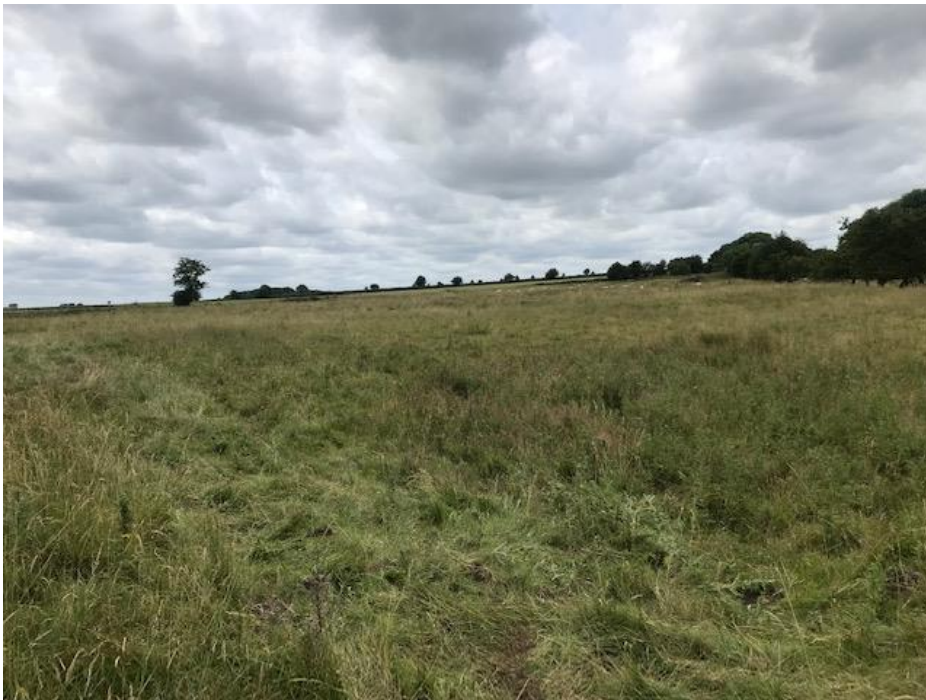
Photo 3

Description: Grassed area in A2. Very bumpy ground, area abandoned due to possible equipment damage and collected data would be too poor to interpolate.

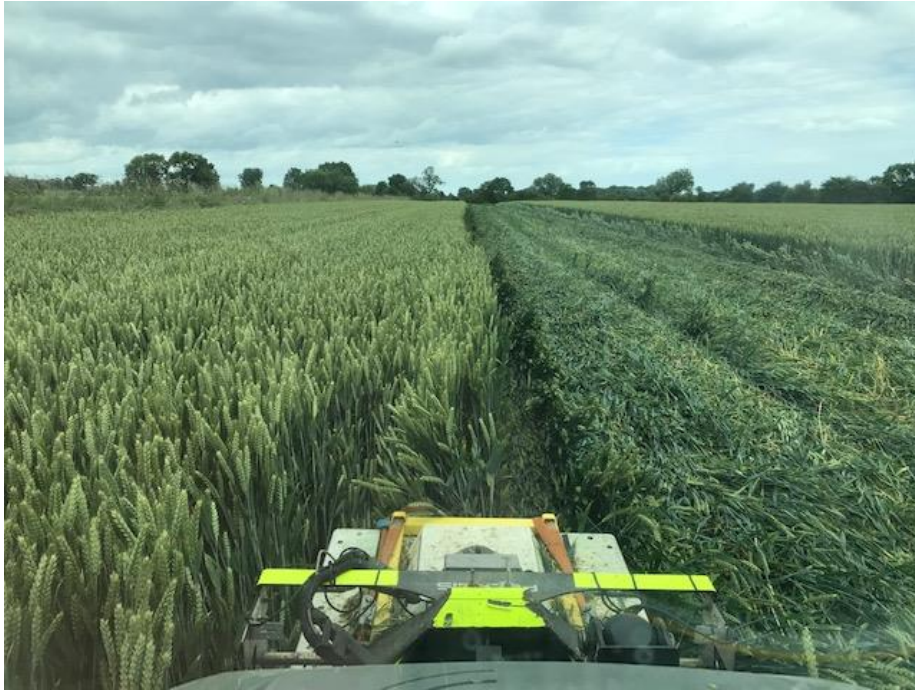
Photo 4

Description: Cropped area in A3. Full coverage achieved except for a pile of rubble towards the bottom of the field. Area around the rubble scanned to eliminate the possibility of any utilities running under unscanned area.

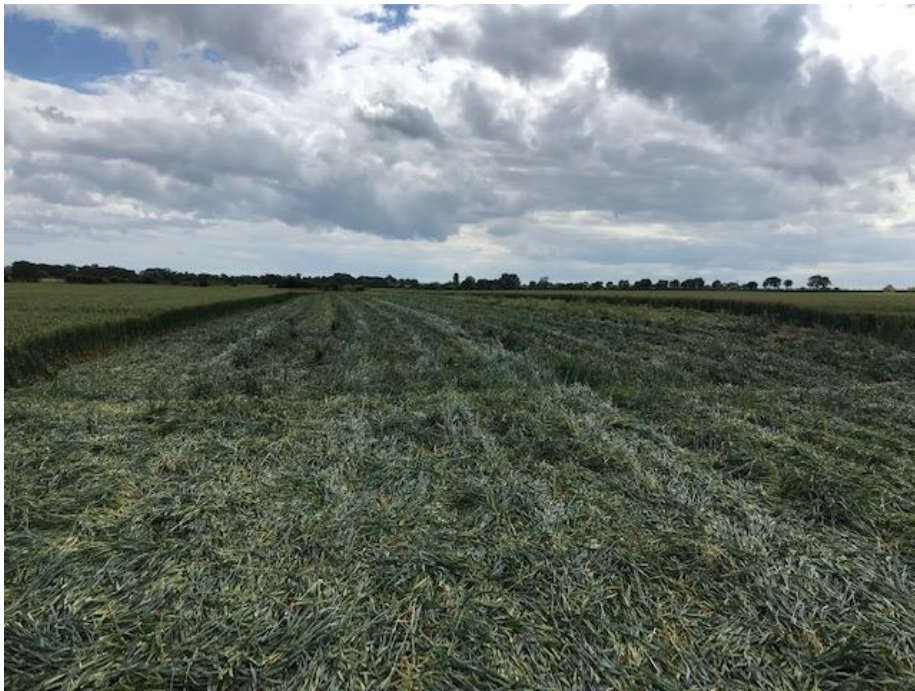
Photo 5

Description: A3 Area after scanning works complete.

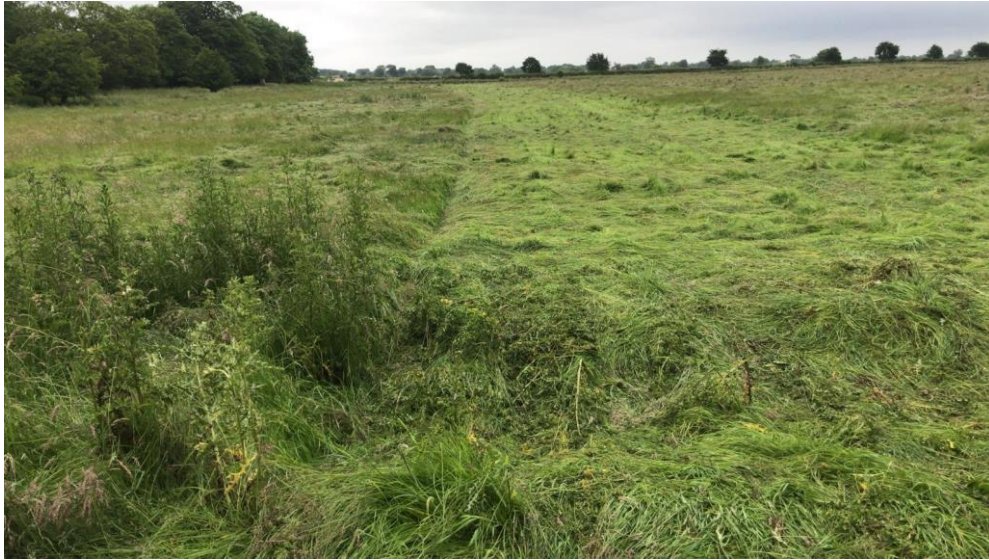
Photo 6

Description: Photo taken halfway through scanning A4. Full coverage achieved except for the concrete bunkers and raised concrete platforms towards the tree line.

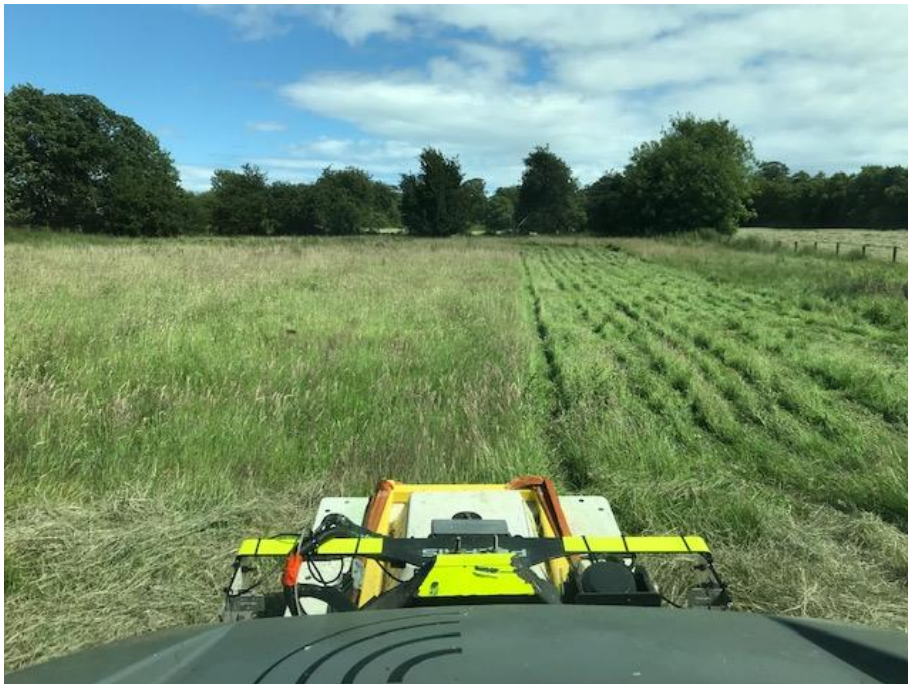
Photo 7

Description: Photo taken halfway through scanning in another part of A4, no issues encountered.

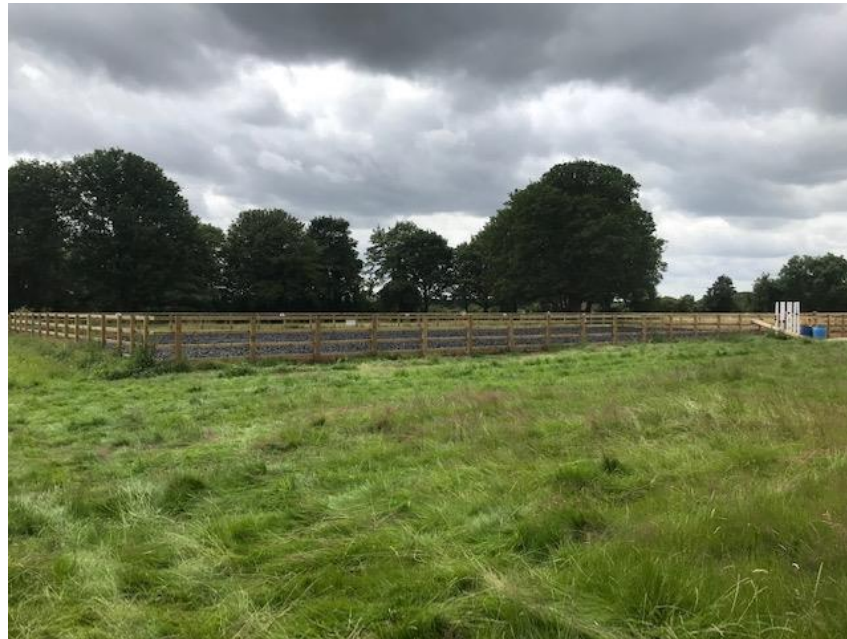
Photo 8

Description: Horse training area in A6, owner asked us not to scan inside due to new chippings being put down for the horses. Perimeter of fencing covered.

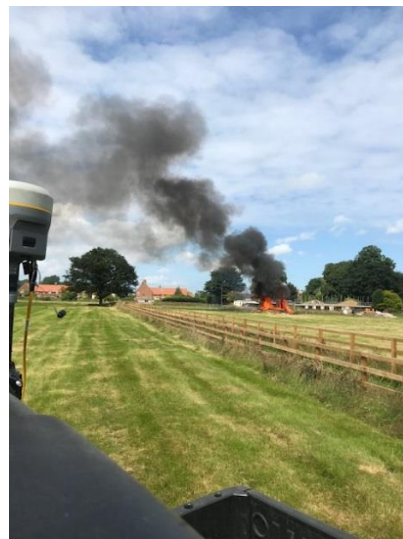
Photo 9

Description: Field owner had a bonfire beside scanned area. Some of this area scanned short due to fire, and another area scanned short due to the smoke from the fire becoming very thick/black and covering the field.

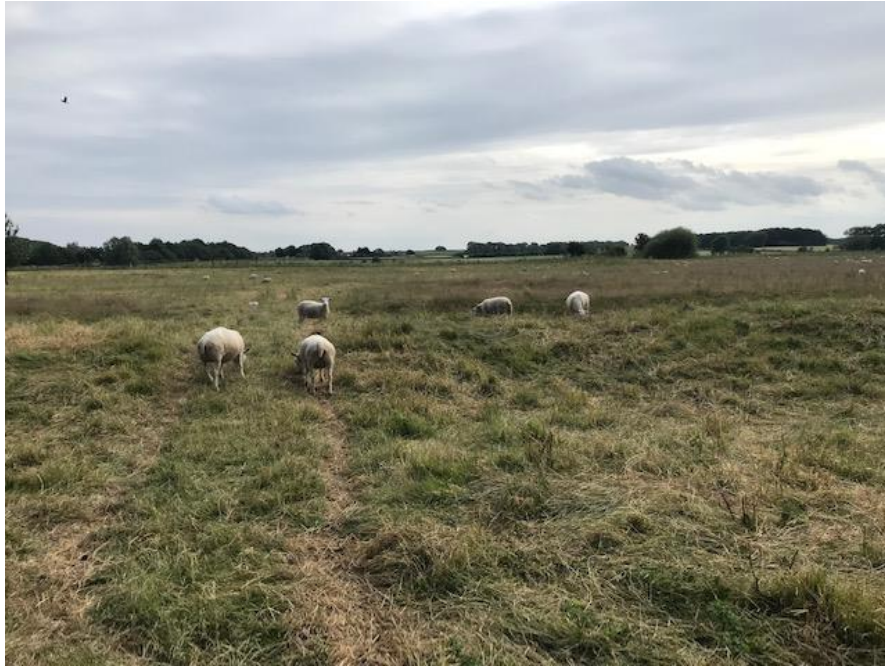
Photo 10

Description: Field in A7, ground too uneven to survey, damage to equipment would occur and radar data would be too poor to interpolate

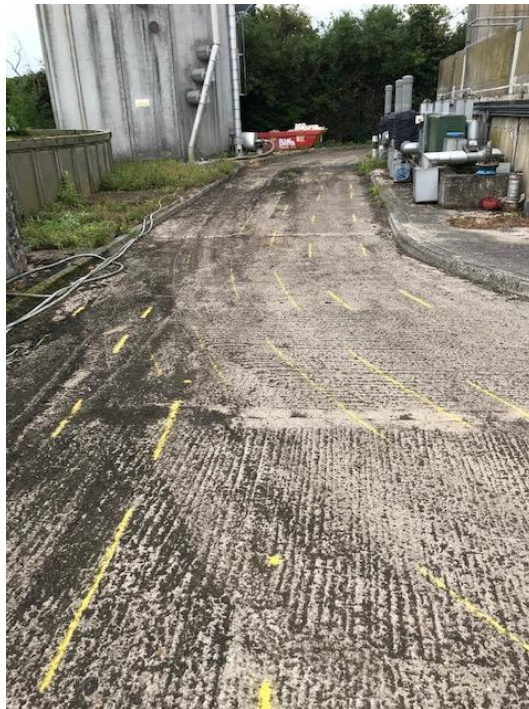
Photo 11

Description: Extended area: Treatment works. Photo of ground coverage. Some grassed area and road covered. Other areas too small/not safe to survey.
